Michener Drain Stormwater Baseline Report

October 30, 2018

Project No: EWB-189999

City of Port Colborne
Michener Drain Baseline Report

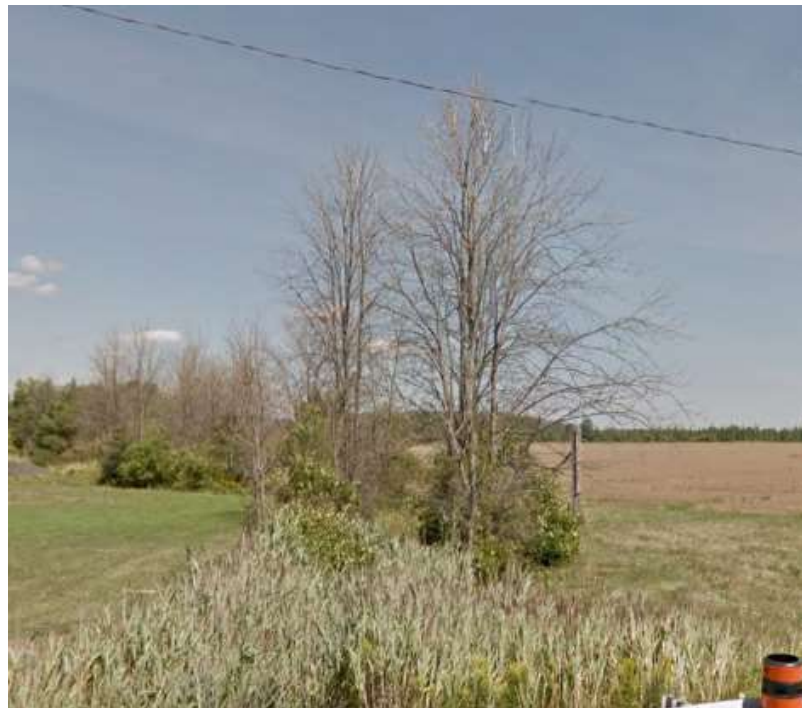
Figure 7 Dead Ash trees within drain banks

The presence of ash trees allowed to grow within the drain banks previously, which are now dead or dying from the emerald ash borer will provide a source of wood debris that may potentially block the drain and cause backwater or other degradations in performance.

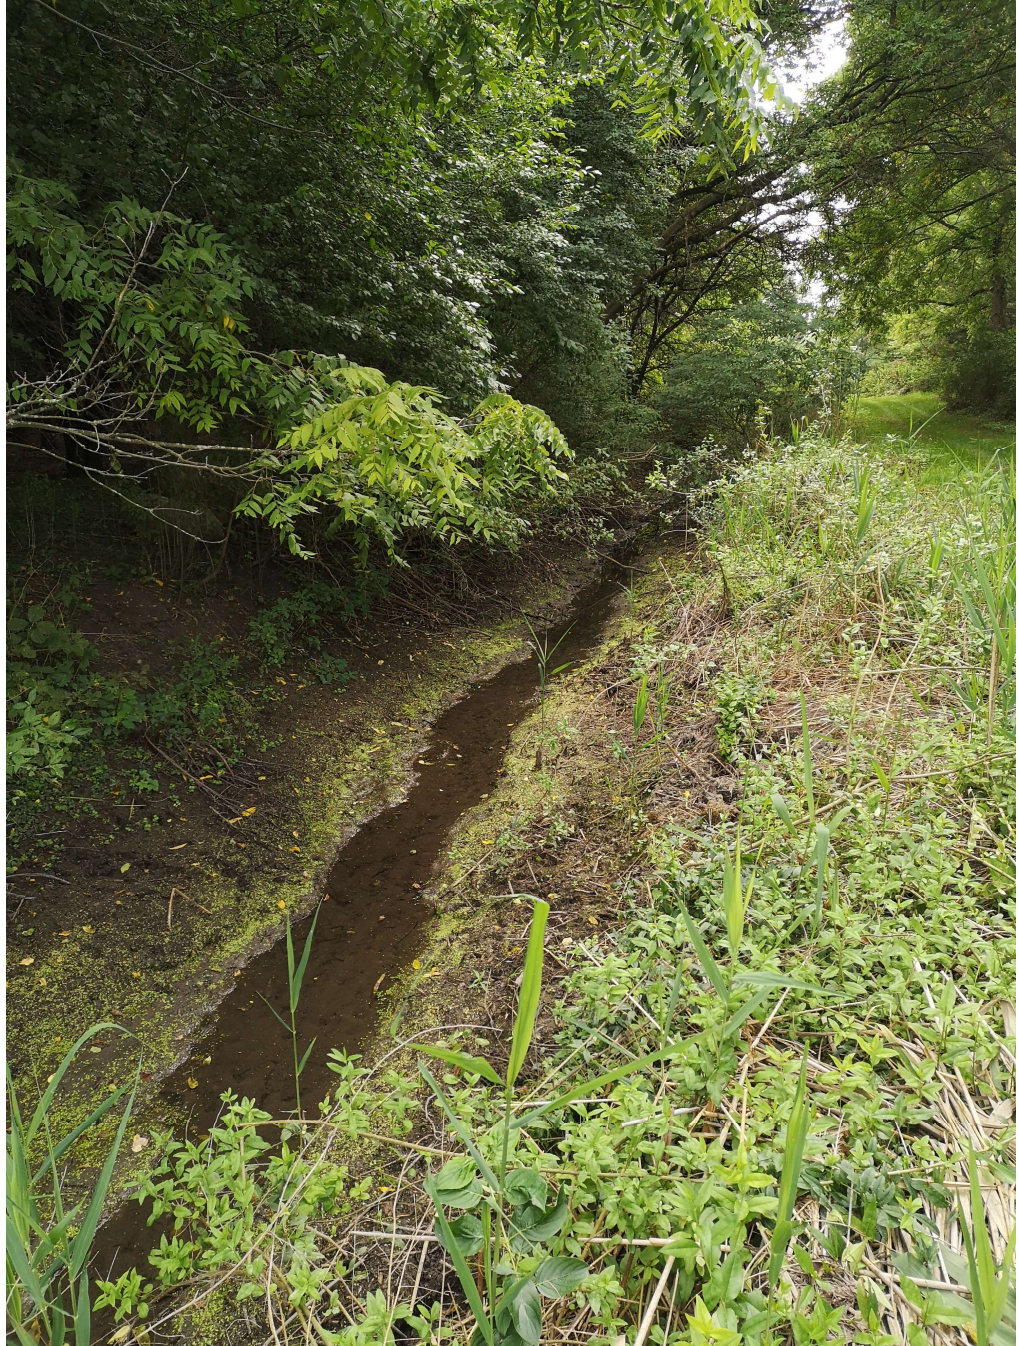
Figure 16 Michener Drain Looking South to Section 2 STA 0+400

This section is part of the reversing flow that the golf course has established to push water into the irrigation ponds located at the Western edge of the golf

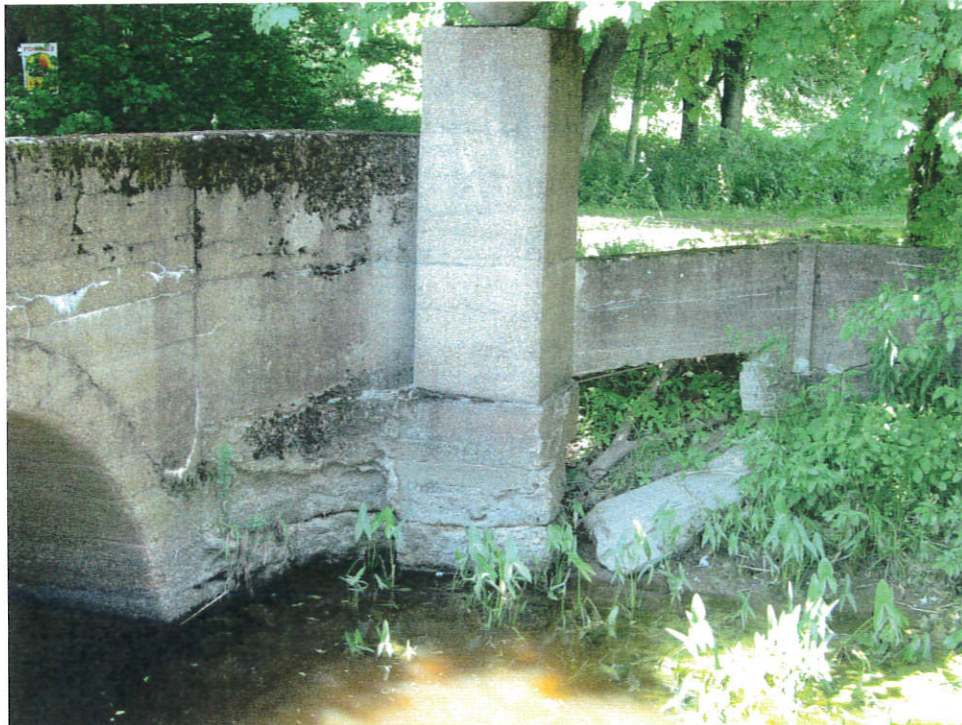
Concrete has deteriorated and broken away, at the northwest wing wall

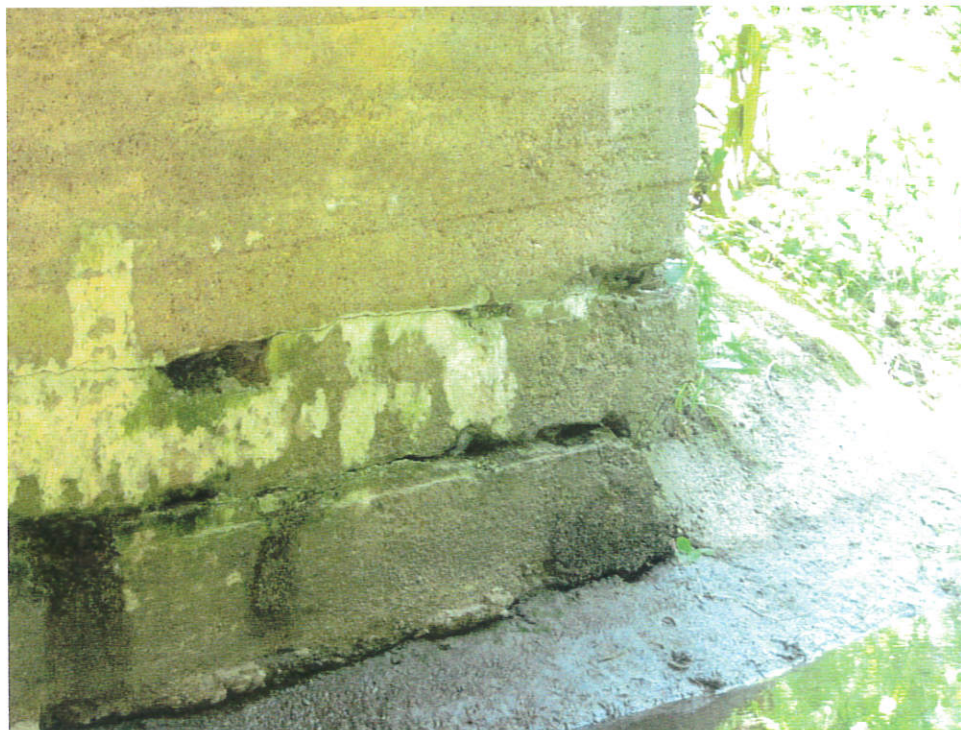
Large cracks on the north end of the west abutment wall

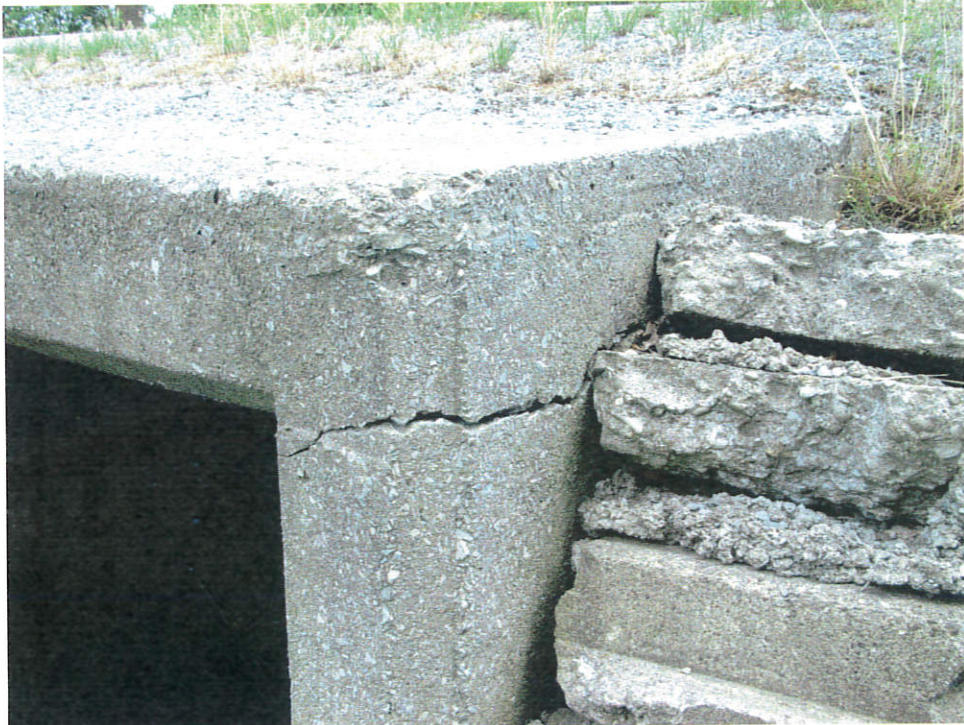
Cracking at the southwest corner of the structure

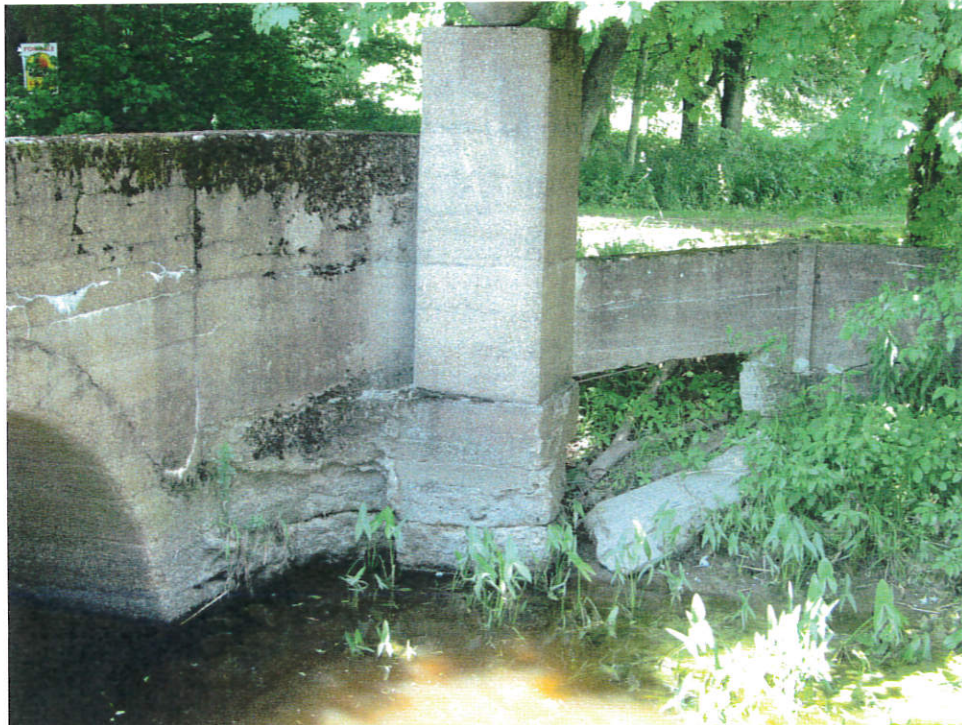
Concrete has deteriorated and broken away, at the northwest wing wall

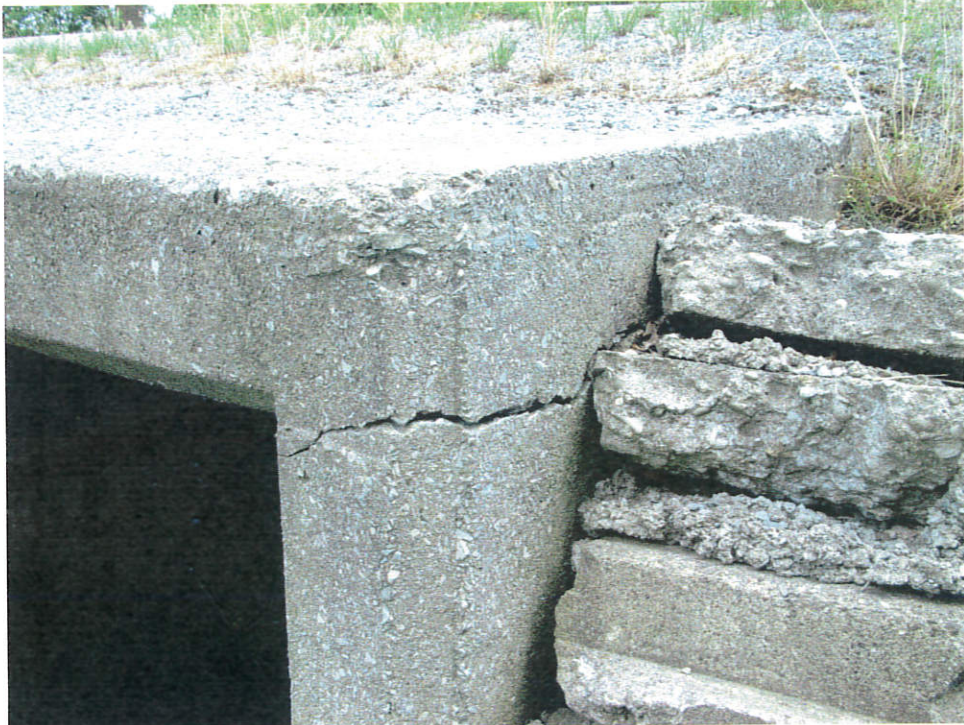
Cracking at the southwest corner of the structure

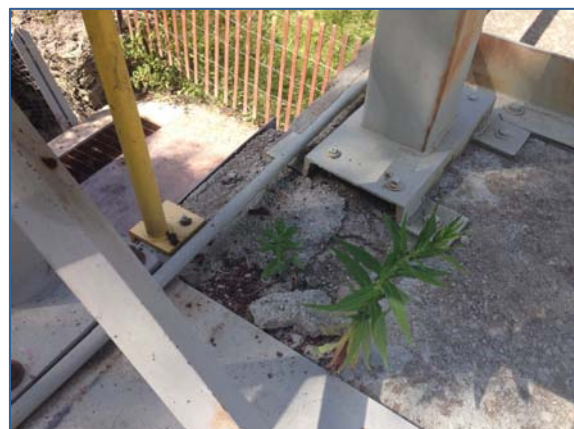
Figure 3: Localized Concrete Spall

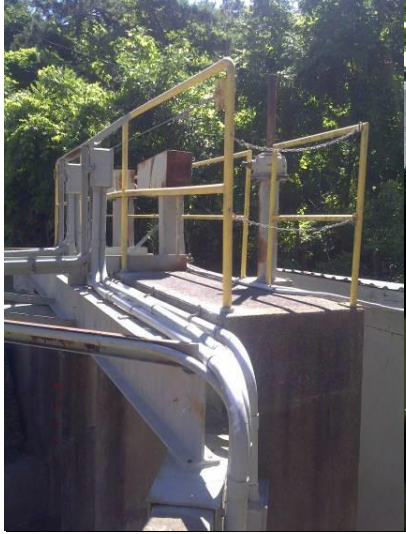
<p>Illustrates the condition of the walkway and railing system, providing safety protection for operations staff working on the dam gate mechanisms. This appears to be too narrow and not in accordance with the latest building codes and regulation requirements.</p>
1. Hydro Transformer Feeding Station

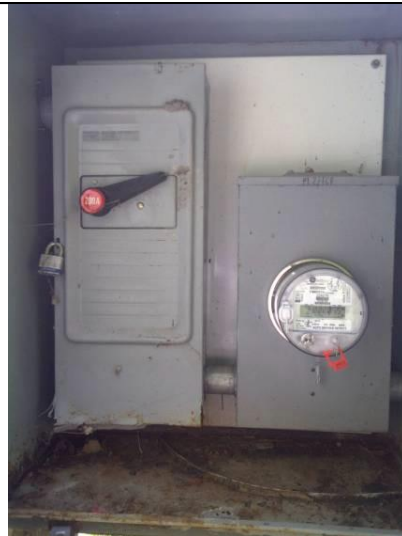
A separate feeder runs from the hydro pole to the disconnect and metering equipment (as shown in the picture) to supply power to two river pumps. Only river pump 2 remains installed. River pump 1 has been fully removed. The disconnect equipment is connected directly to the starter panel shown in picture 3. The equipment appears to be in good condition.

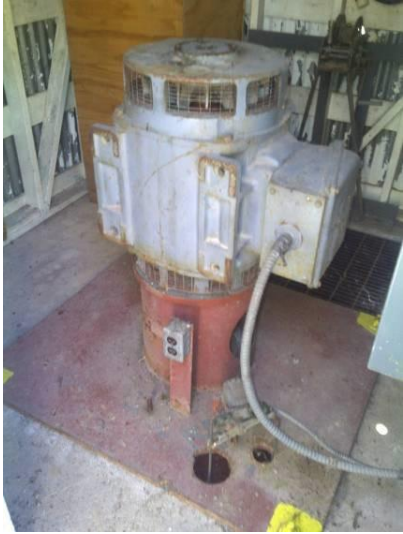
<p>The Well Pump Motor is showing significant signs of aging and should be replaced along with its starter (refer to picture 7).</p>
6. Pump House Metering and Power Distribution

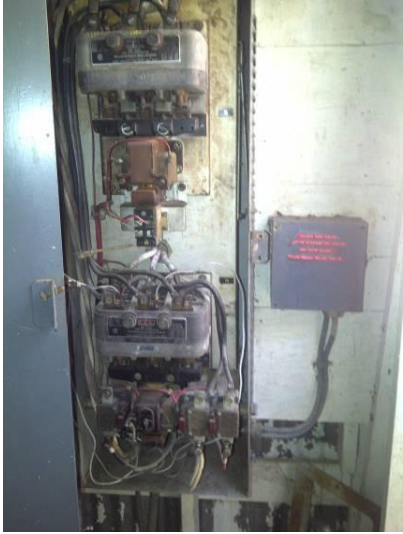
<p>The Well Pump Starter is well beyond its asset life and must be replaced as it no longer meets code and regulatory requirements.</p>
8. Outdoor Light

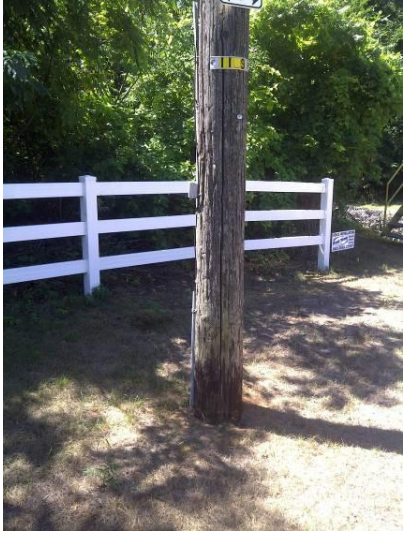
<p>The hydro pole is showing significant signs of aging and should be replaced.</p> <p>This hydro pole is part of the utility's mainline which may very well represent the overall condition of the mainline as in the age of the transformer, however it is not a specific component of the Wignell/Michener facility.</p>
MECHANICAL		
1. River Pump 2

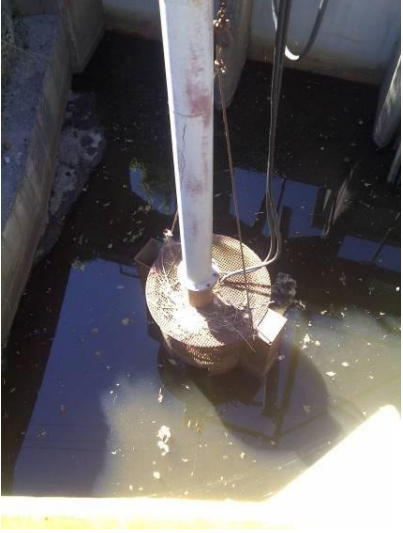
<p>River Pump 2 is showing significant signs of aging and the debris surrounding the protective/filter house greatly diminishes its usefulness and operational capability. River Pump 1 has already been removed most likely due to the protective/filter housing issue and the difficulty of maintaining the unit in its present location. We recommend replacement if the pump 2 is to remain in the future operation of the facility.</p>

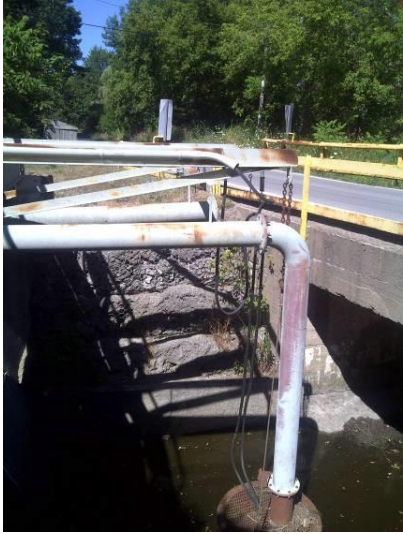
<p>The discharge piping for River Pump 1 has been partially removed. The discharge piping for River Pump 2 is in reasonably good condition. If both river pumps are no longer required, we recommend fully removing the pumps and their associated piping.</p>
3. Dam Gates

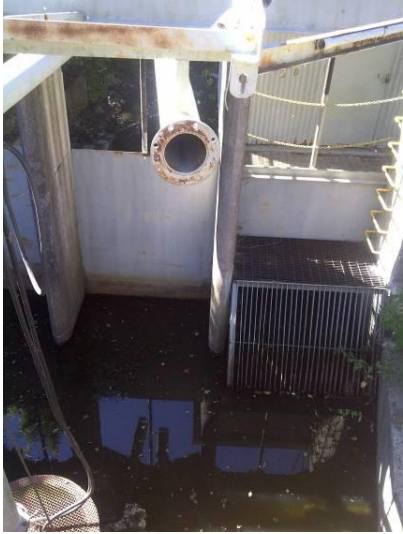
<p>The entry grate to the Dam well appears to be in reasonably good condition. The grate had been previously modified to change the angle of the grate. However, we understand that there is an issue regarding the well elevation that limits the pumping capability of the well pump. This should be further reviewed before making a recommendation on how to proceed.</p> <p>There is correspondence early on after the installation (circa 1973) where modifications in</p>
5. Mechanical Well Discharge Gate Hoist

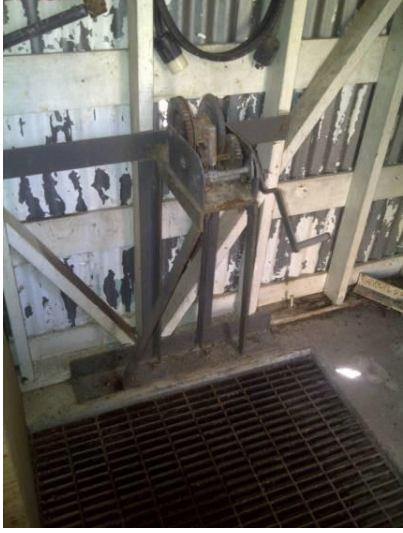
<p>The Hoist appears to be in reasonably good condition.</p>

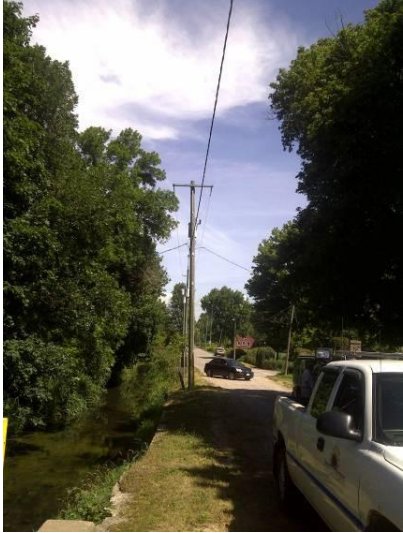
<p>Hydro pole and transformer are in reasonably good condition. Hydro feeds the structure lighting only.</p>
<p>MECHANICAL</p>
