Michener Drain Stormwater Baseline Report

October 30, 2018

Project No: EWB-189999

City of Port Colborne
Michener Drain Baseline Report

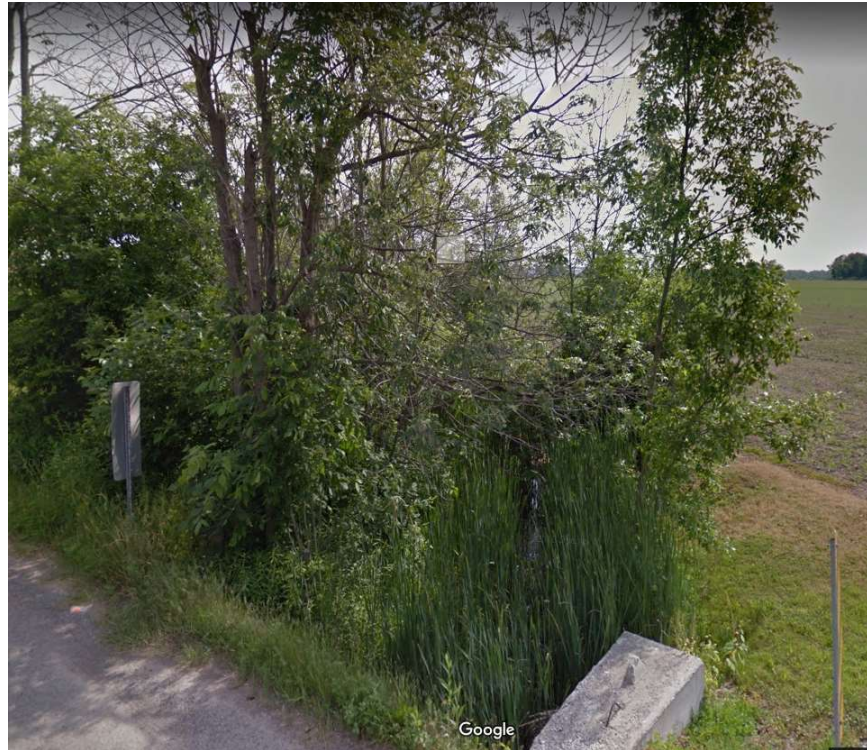
Figure 6 Vegetation obstructed drain

This flow is obstructed by tree growth within the banks. Bull rushes provide evidence of standing water. The expected performance of the culvert based on this approach is compromised and unlikely to perform as designed or expected.

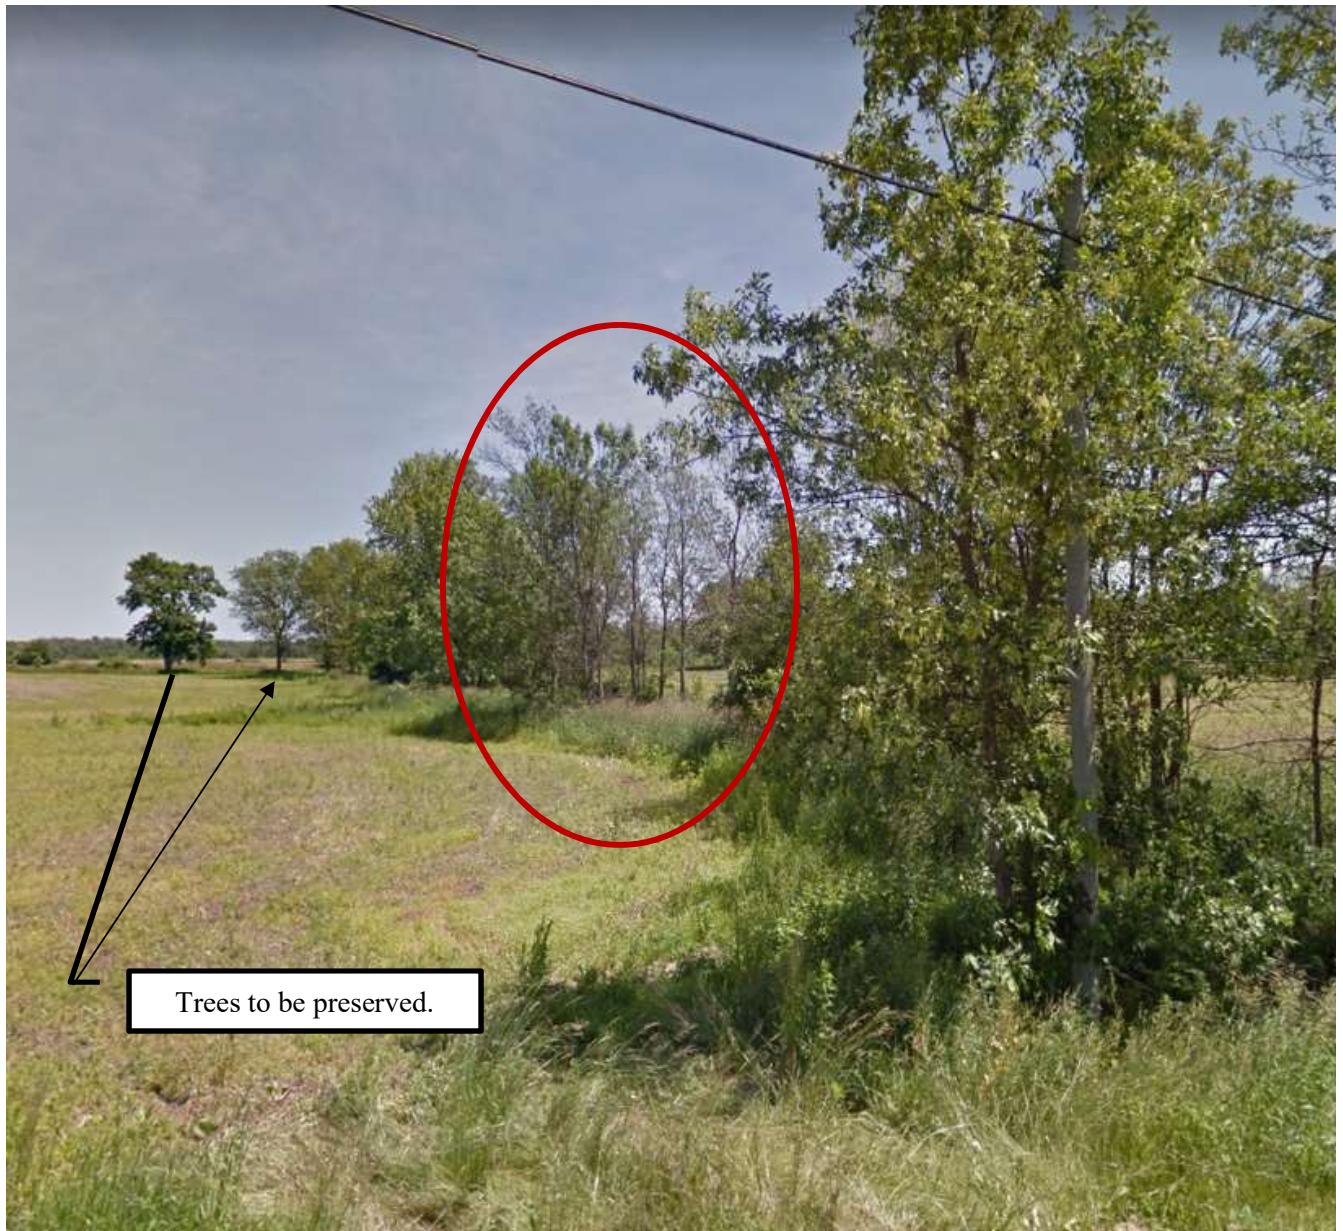
Figure 8 Selective tree removal

Individual trees, as shown in Figure 8 Selective tree removal, that are currently healthy and with a good expectation for continued good health should be

preserved and protected during construction. Trees that group both side of the drain and create an obstruction to flow are to be removed, (red circle in Figure 9).

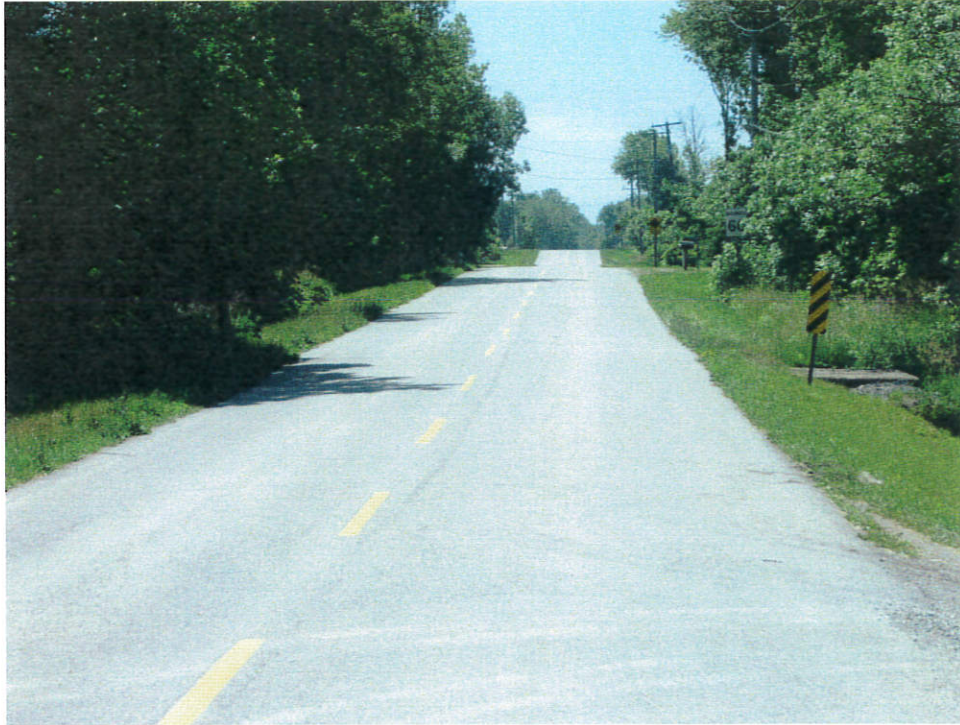
Roadway over the structure - Looking south

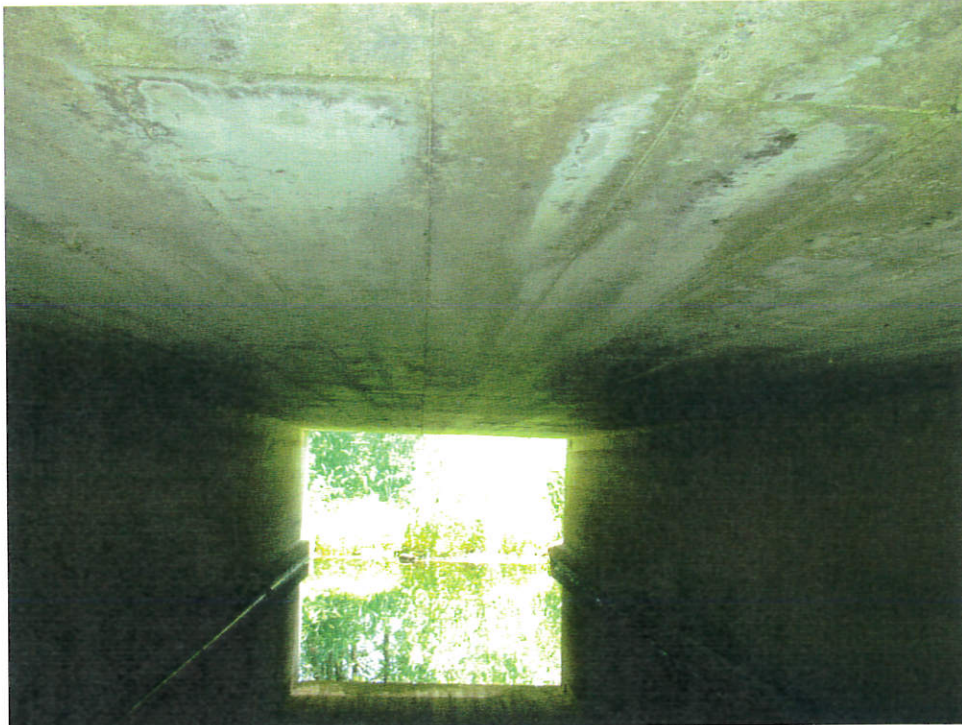
View of the interior of the structure, from the west end

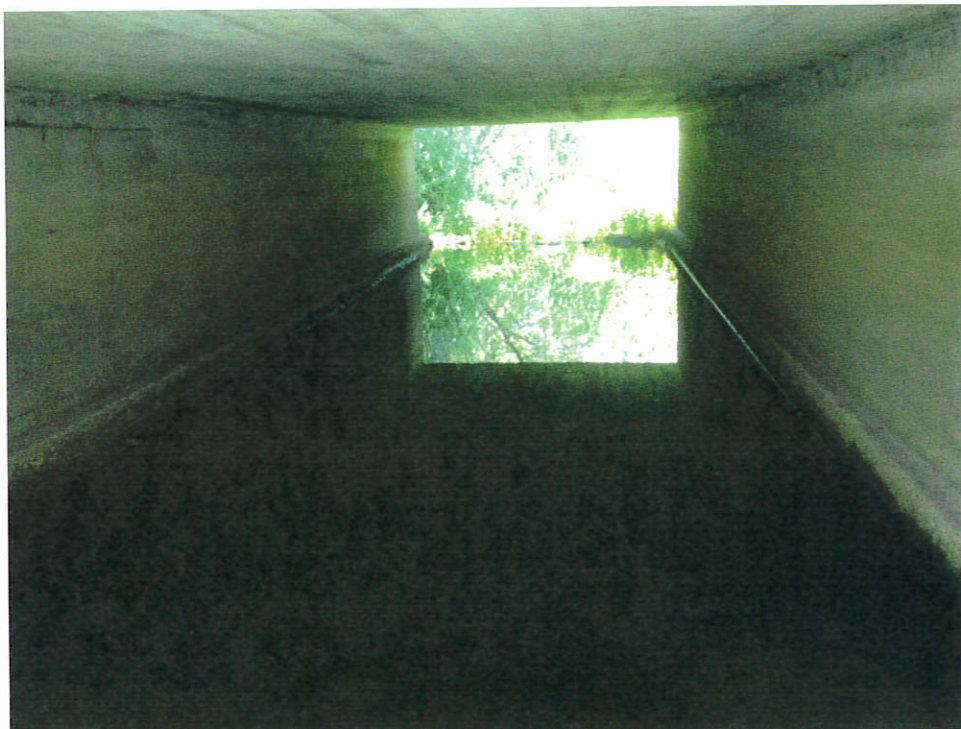
View of the interior of the structure, from the east end

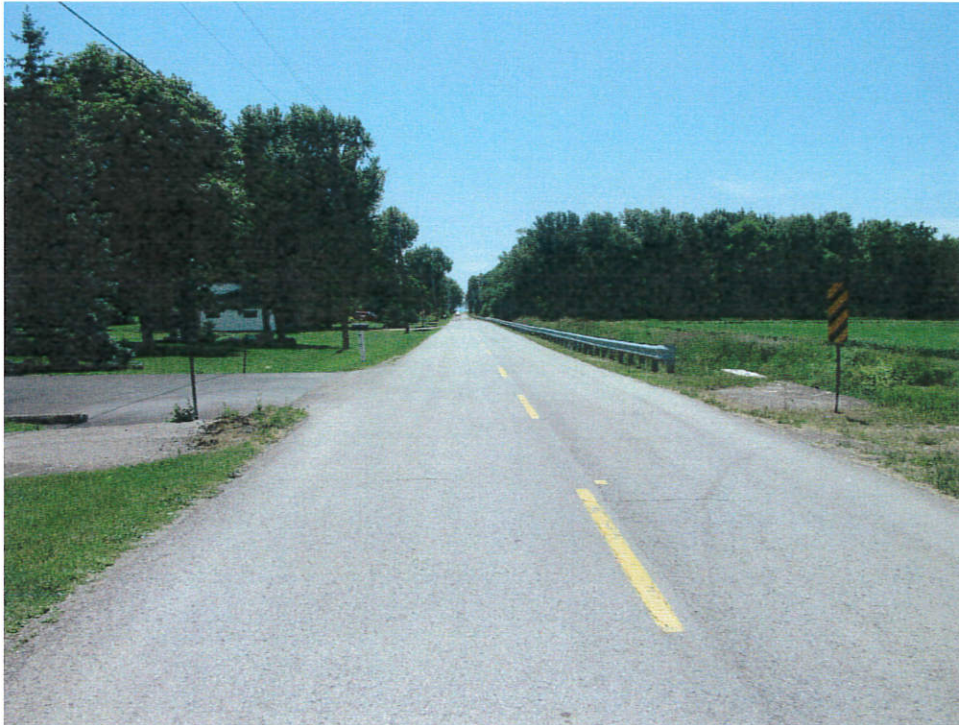
Roadway over the structure - Looking south

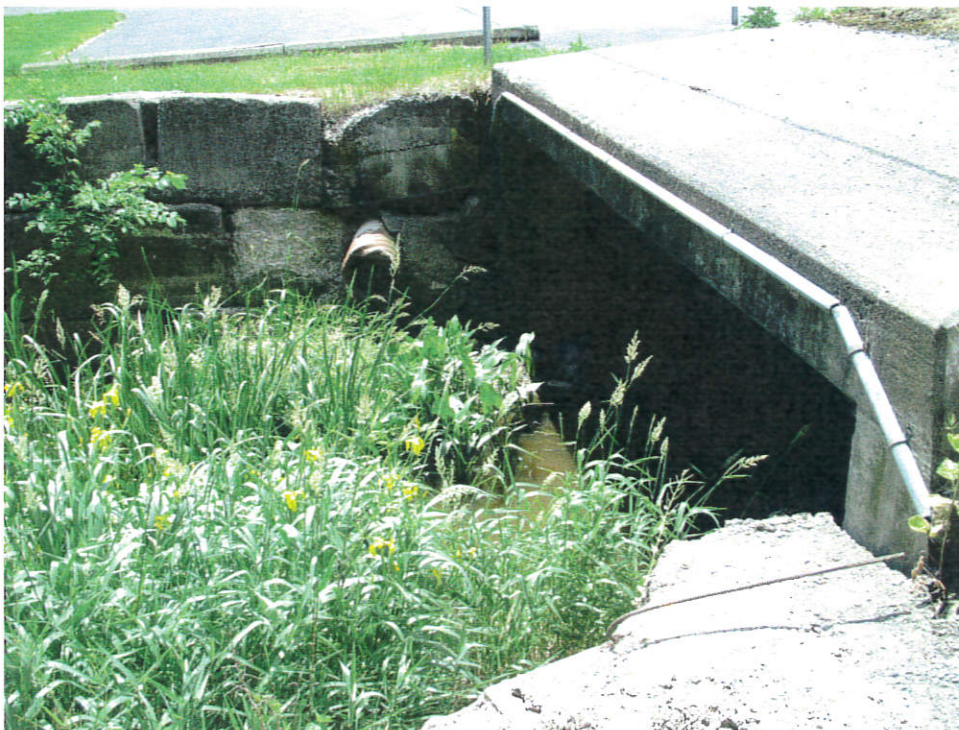
The east end of the structure

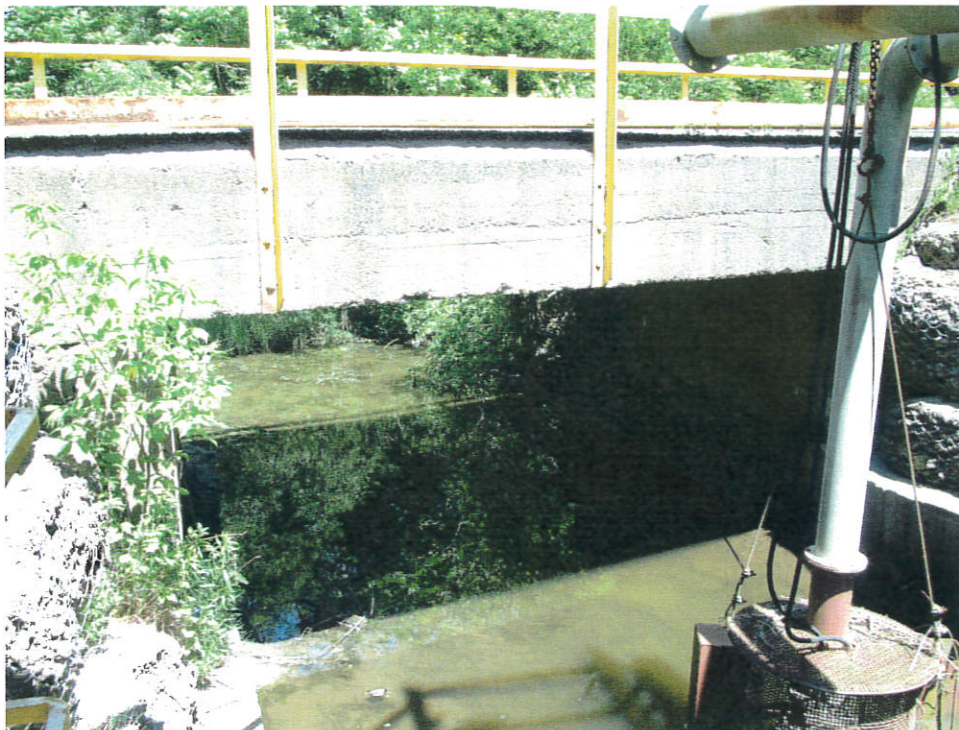
The south side of the structure

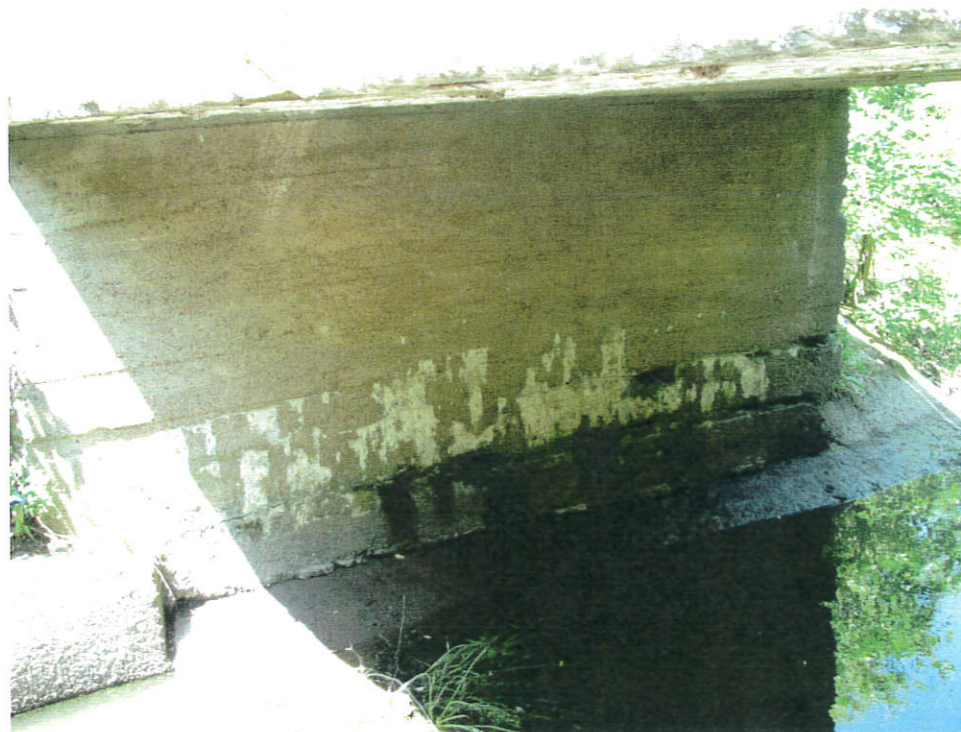
The west wall of the structure

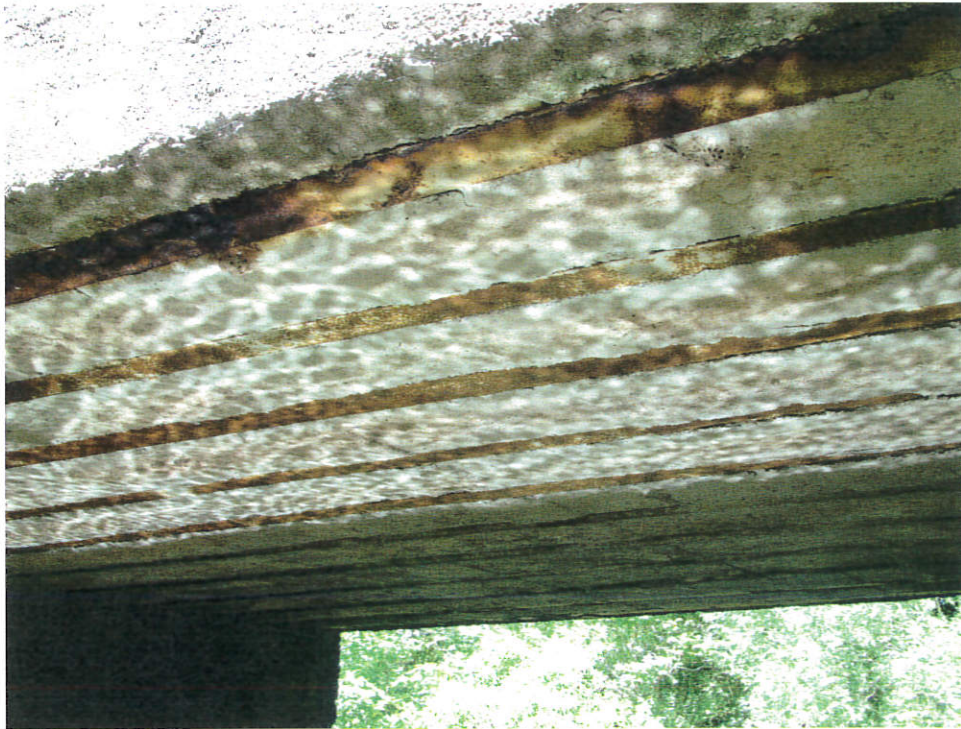
The underside of the structure

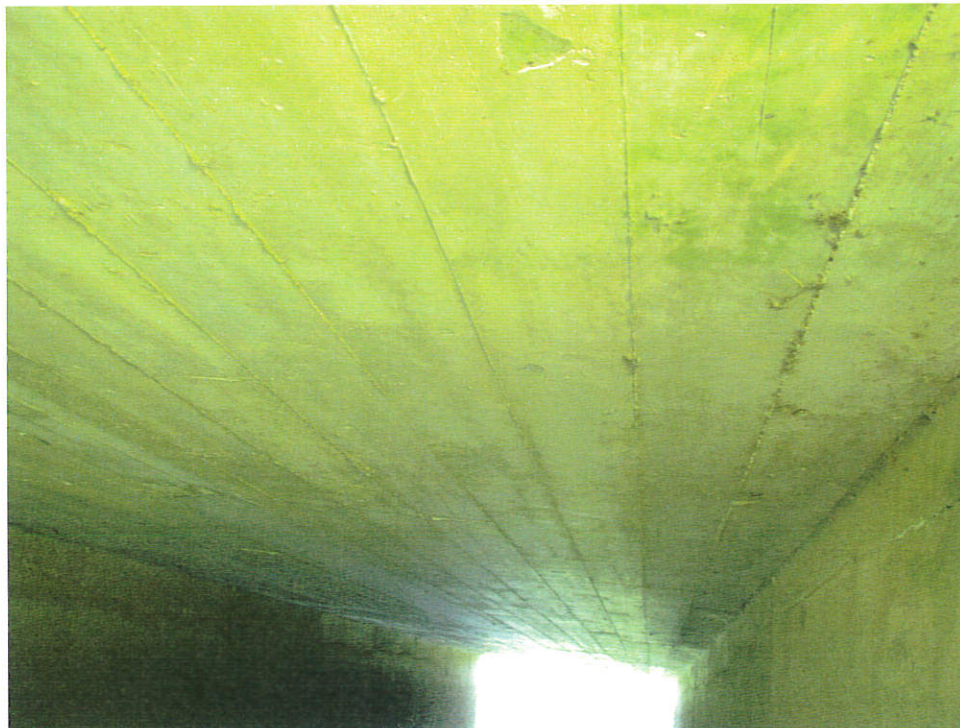
The underside of the structure

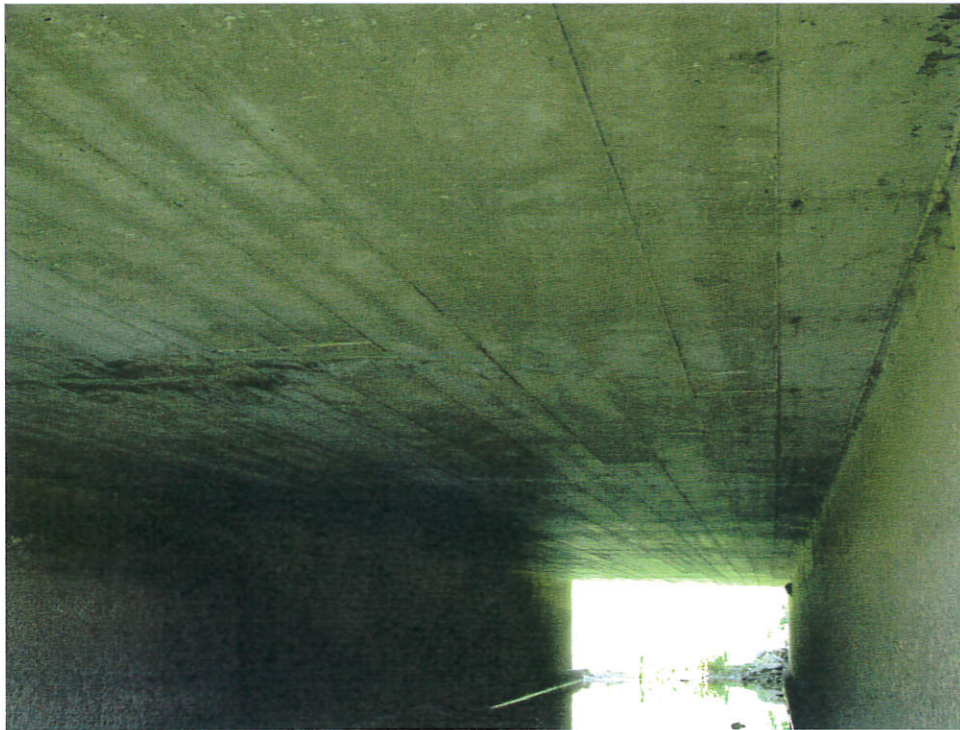
Viewing the interior of the structure, from the south end

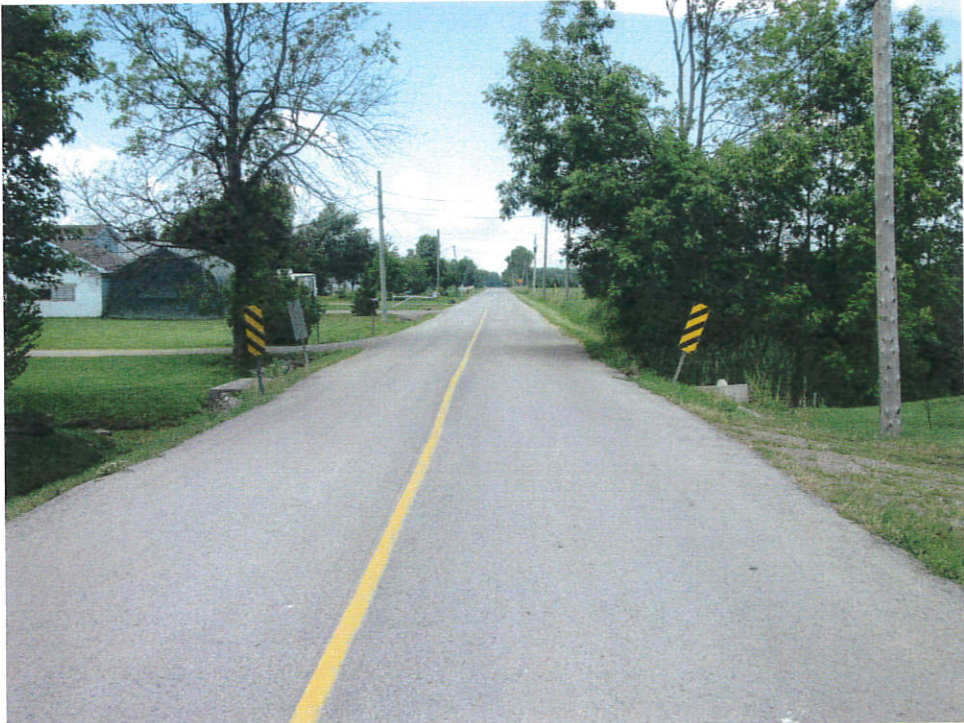
Roadway over the structure - Looking north

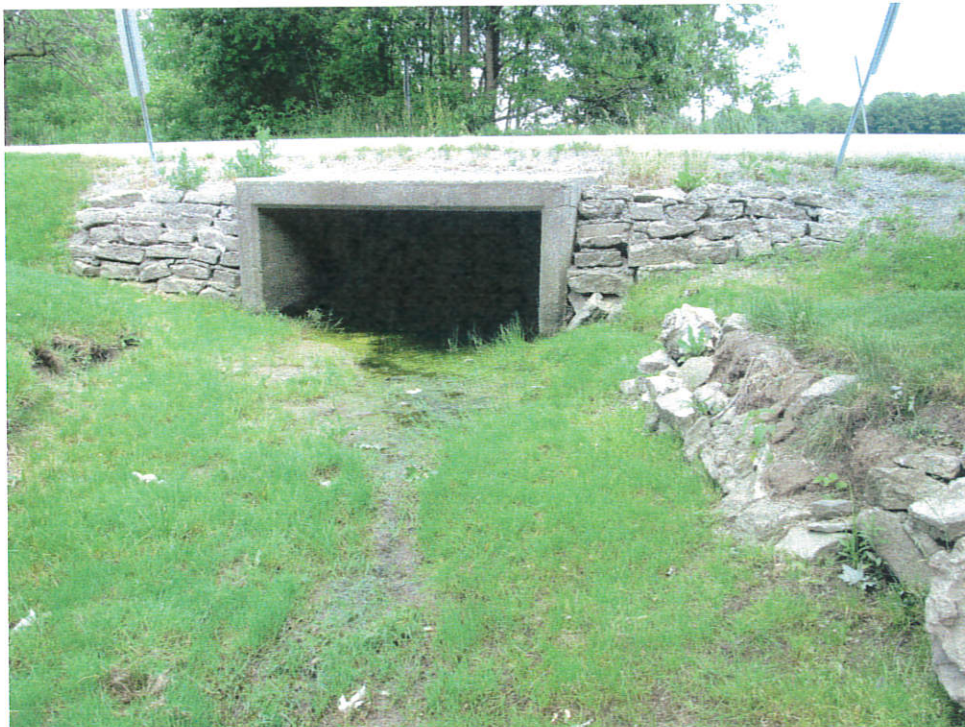
The west end of the structure

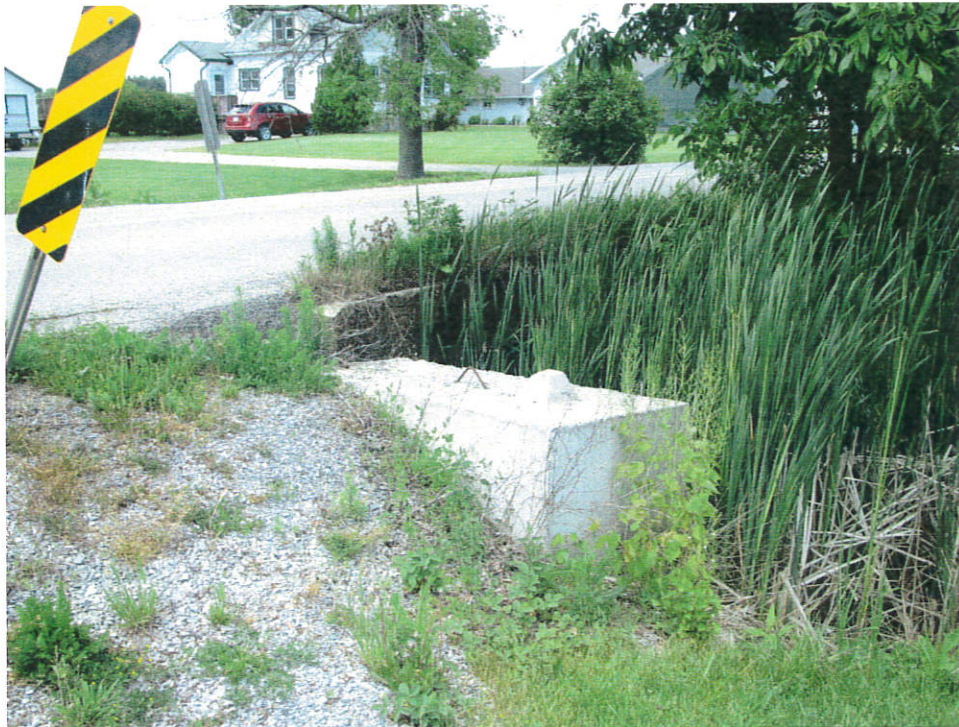
The east end of the structure

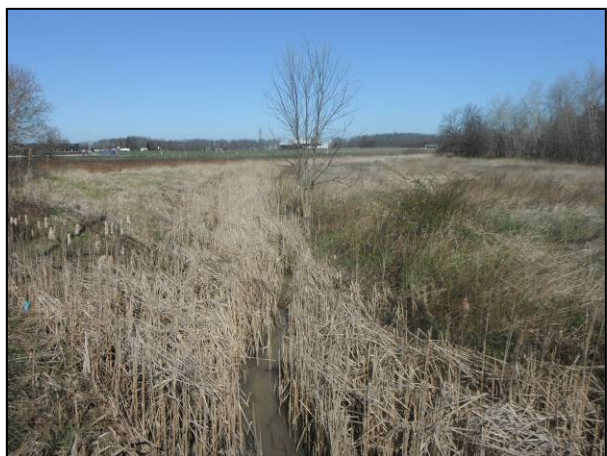
Photo 6: Reach 4-WM showing cattails in drain

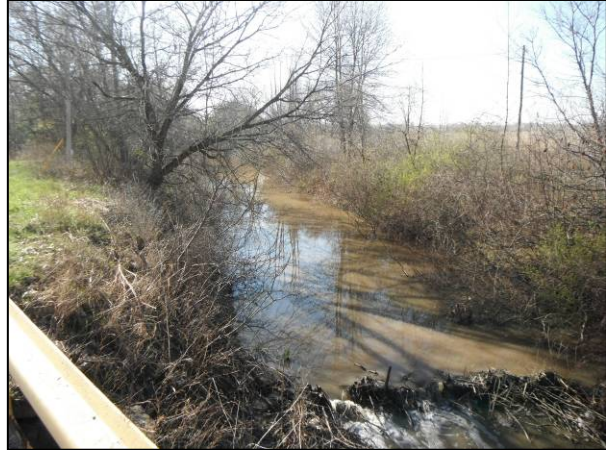
Photo 15: Reach 10-WM, typical drain character, except for beaver dam in foreground of photo

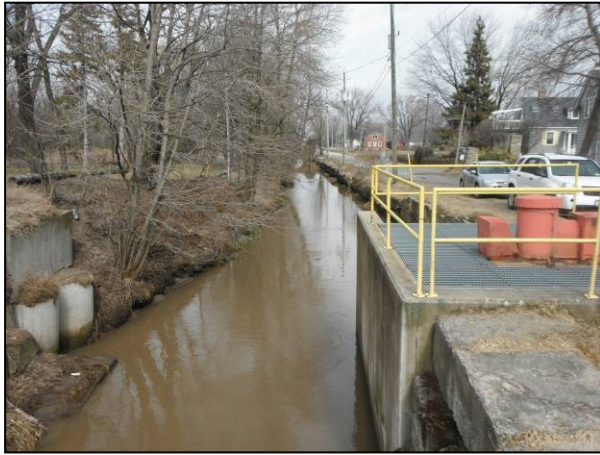
Photo 37: Reach 1-B, water control structure

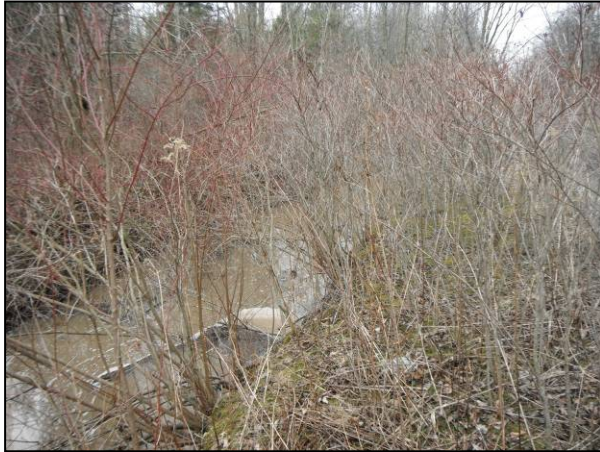
Reach 5-B enters a deciduous swamp running east-west, then makes a 90-degree bend to run north-south towards the Friendship Trail, then continues at a northeast angle to end at Killaly Street East. This reach is fully treed on both sides throughout its length except for a small patch of meadow marsh adjacent to Killaly Street East. The banks on both sides of the drain are former spoil banks and appear to be at a higher elevation than the surrounding swamp.

Photo 45: Reach 5-B shrubs adjacent to channel

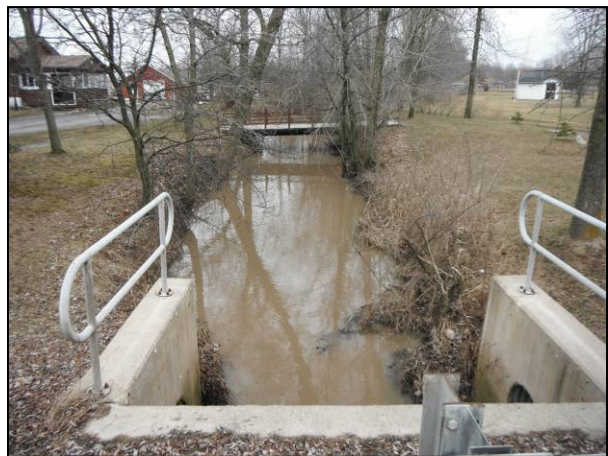
Photo 48: Reach 6a-B, Hwy # 3 culvert crossing headwall & lateral drainage (piped roadside ditching)pipinginterface. Former Geo. A. Schooley Award Drain. 16

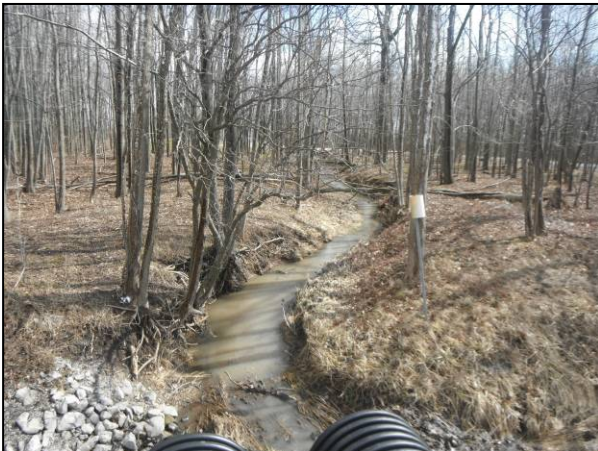
Reach 14-B runs within a deciduous forest that extends from Miller Road approximately 100m eastwards. This reach is fully treed on both sides and runs within one private property.

Photo 62: Reach 14-B, channel character, Miller Road cross culvert at point of discharge of roadside ditching system into the West Branch of Beaver Dam Drain.
