Michener Drain Stormwater Baseline Report

October 30, 2018

Project No: EWB-189999

City of Port Colborne
Michener Drain Baseline Report

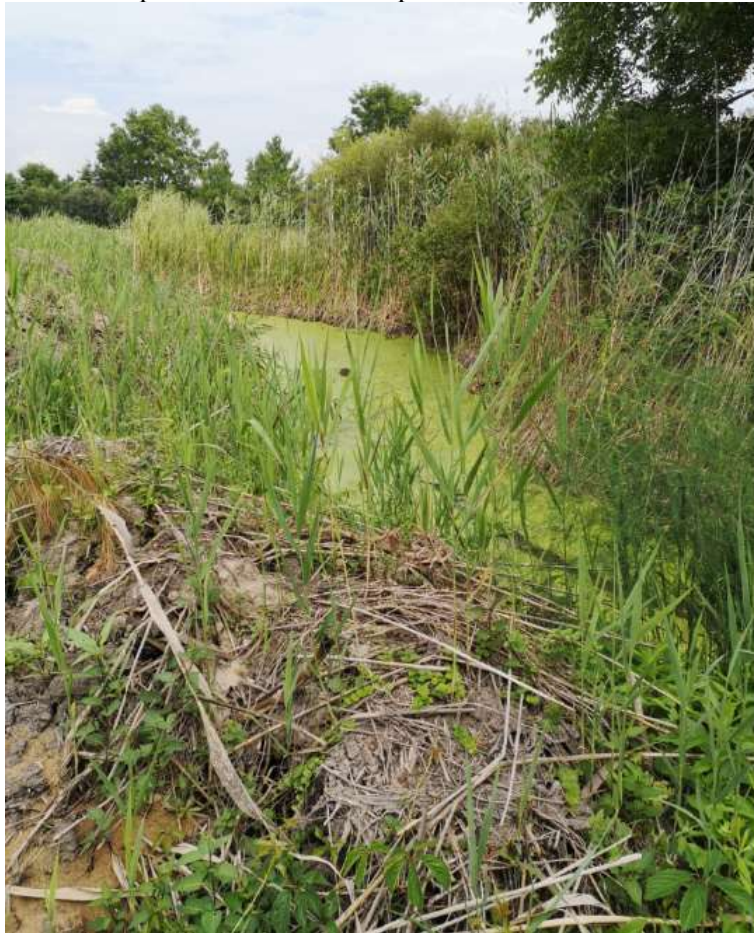
Figure 18 Michener former Sedimentation Facility

- South of the last bridge where the sediment detention facility was expected to be seen, WRGC has removed the sedimentation facility that may have previously existed as was shown in the drawing as the ditch has been excavated to an unknown grade to facilitate moving water backwards up the drain from the upper level pond. The spoil pile is haphazardly arranged along the edge of the drain and the excavation is

not to a shape that would meet expectations.

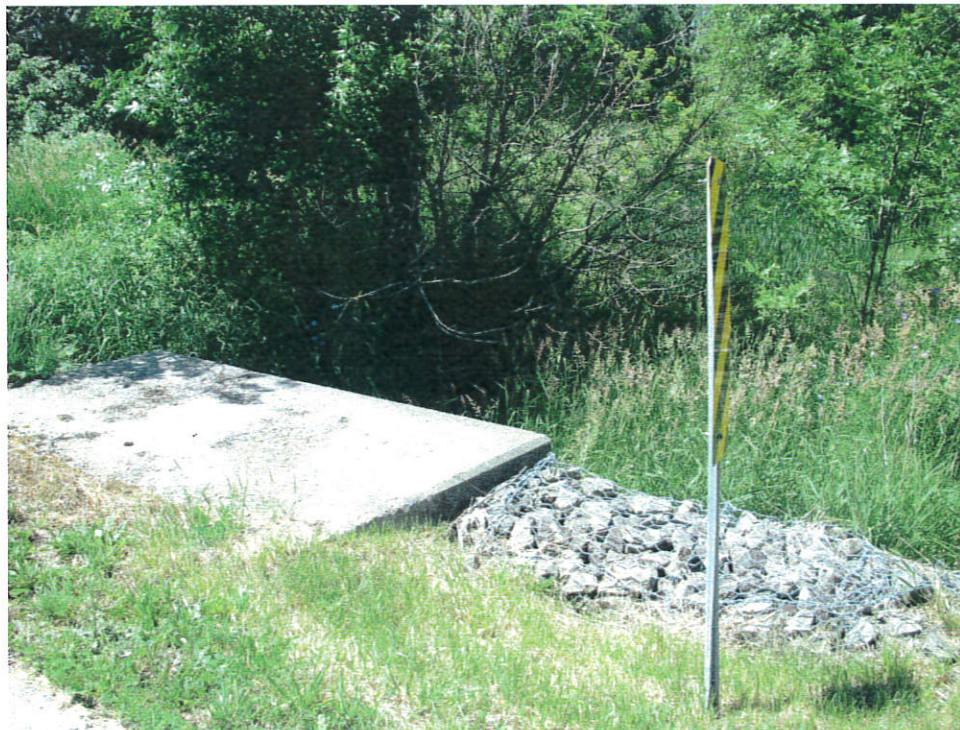
The west end of the structure

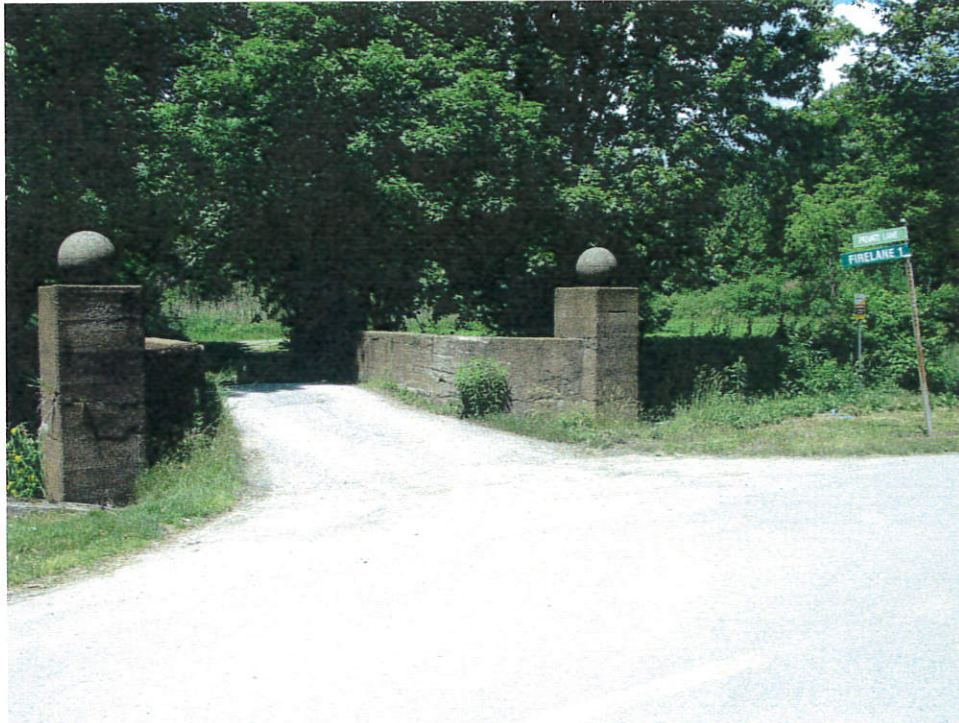
Roadway over the structure - Looking west

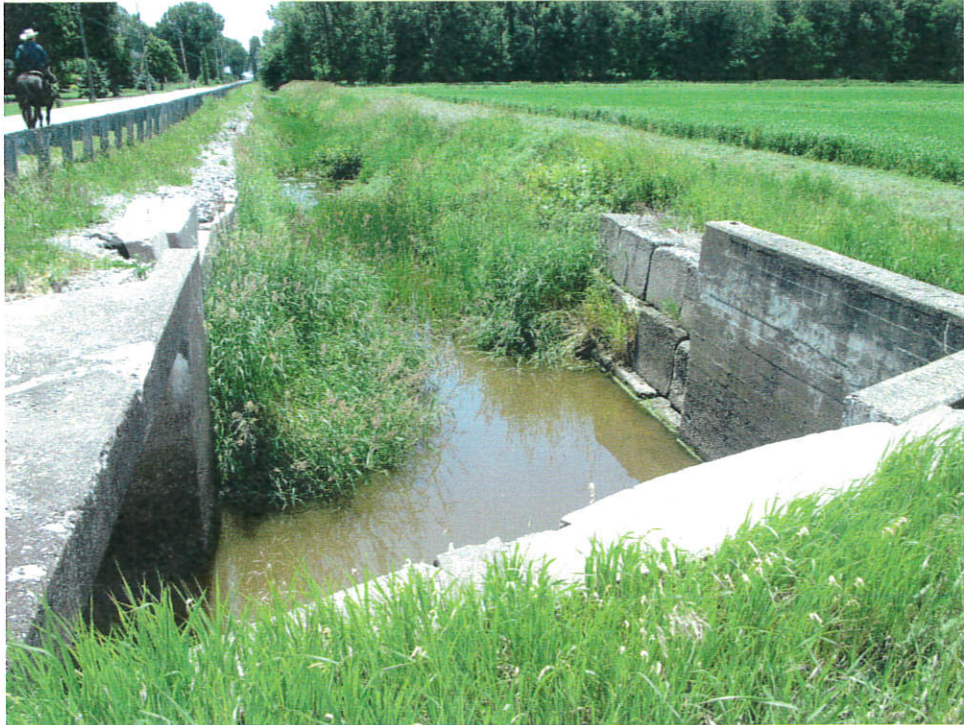
The west end of the structure

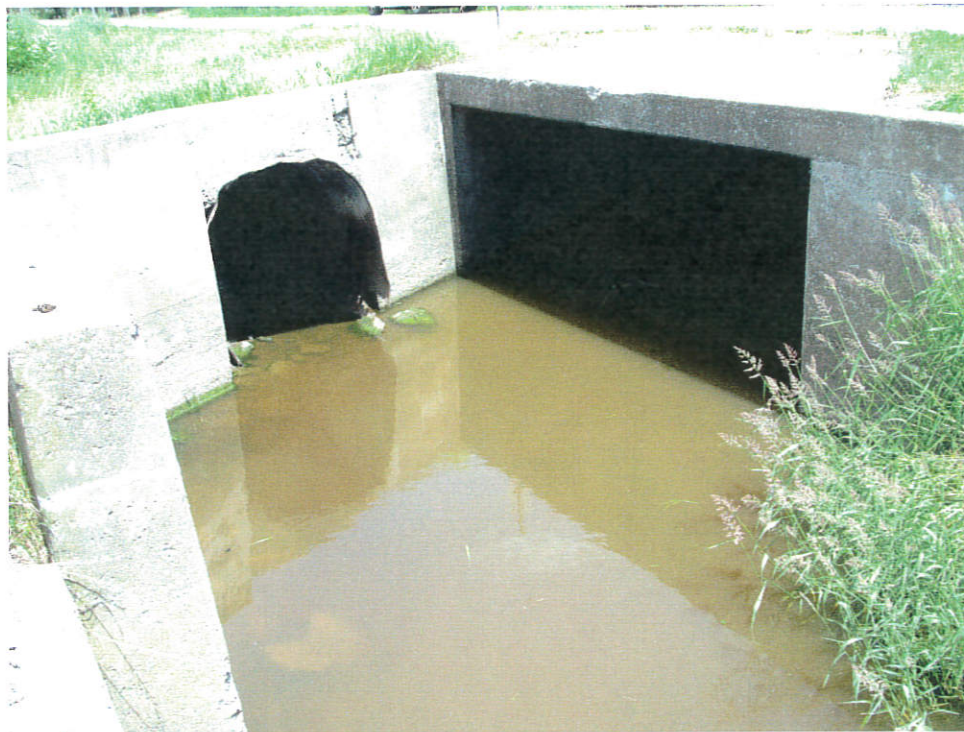
The west end of the structure

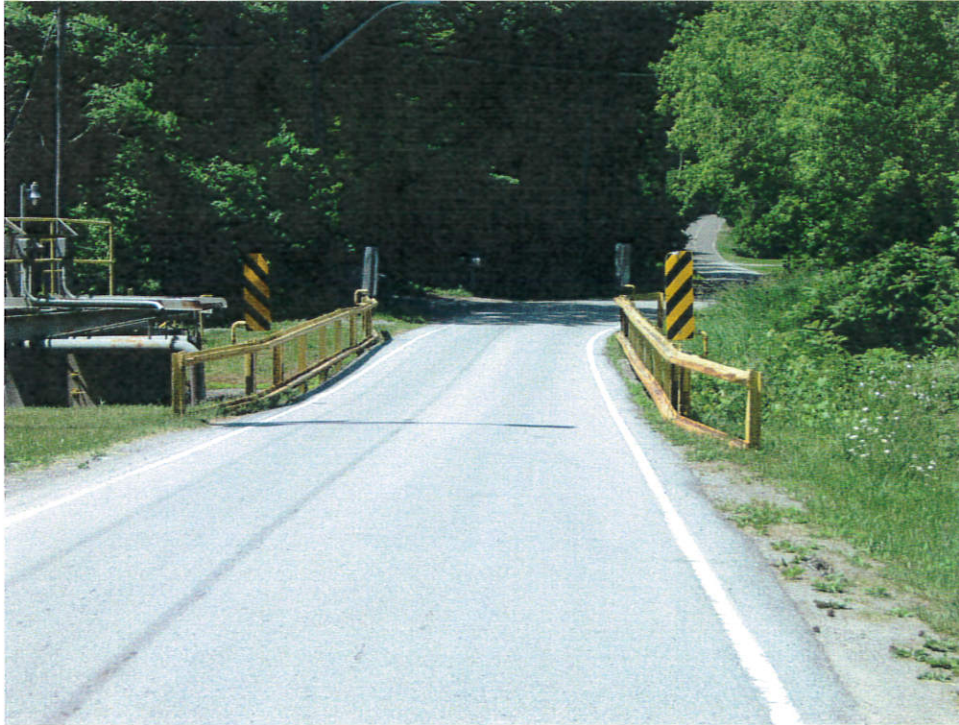
Roadway over the structure - Looking west

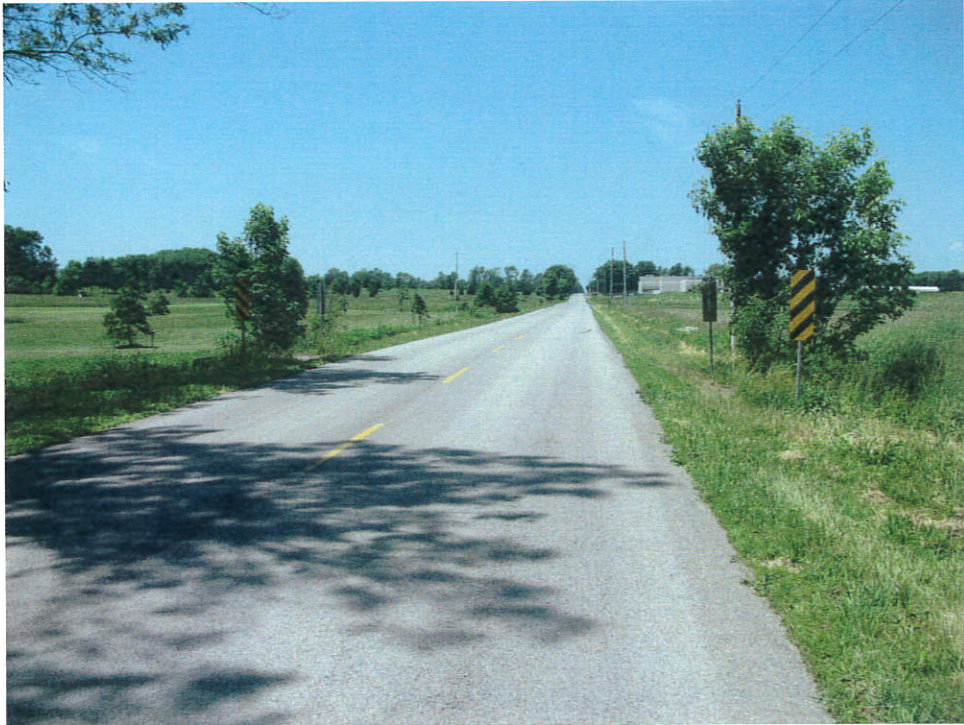
Roadway over the structure - Looking west

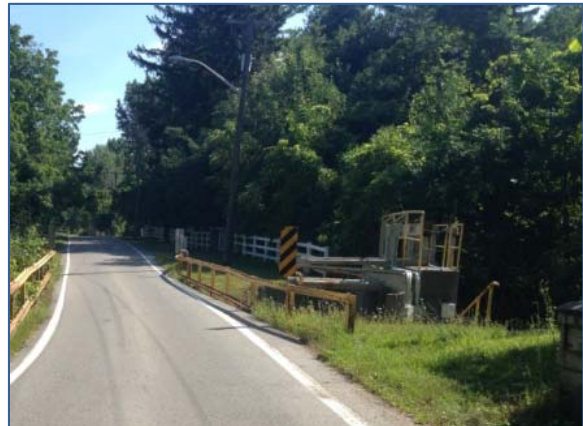
Figure 1: Wignell/Michener Drain

The Wignell/Michener dam structure is located immediately downstream of the adjacent roadway, independent of the roadway structure and connected by an infill retaining structure (ref. Figure 1.) The main dam structure consists of a cast-in-place concrete rigid frame, consisting of three (3) cells (ref. Figure 2), complete with structural steel sliding gate and appertunances, railings and piping.

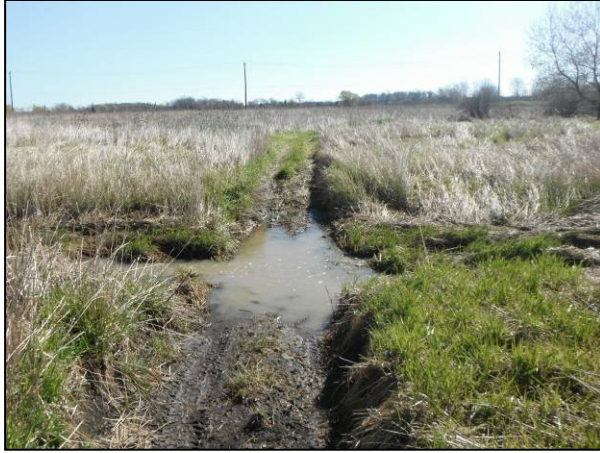
Photo 7: Reach 5-WM, ATV use through drain

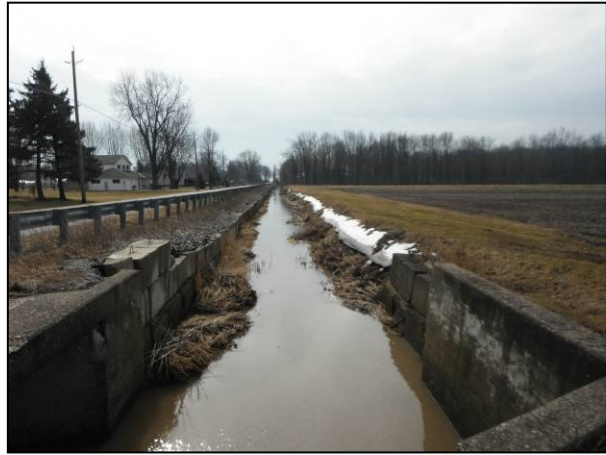
Photo 38: Reach 1-B, hardened banks and adjacent agricultural land

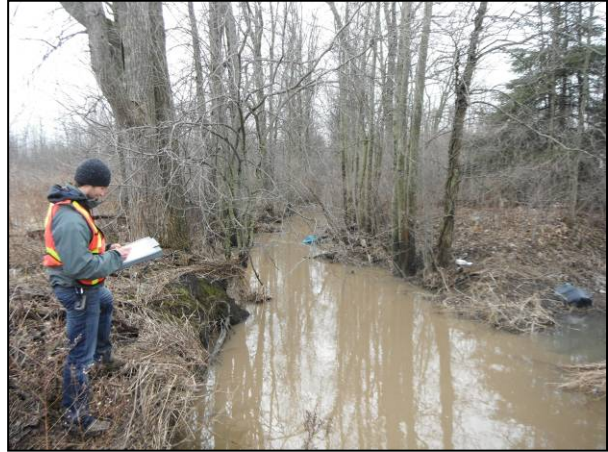
Photo 46: Reach 5-B, channel character

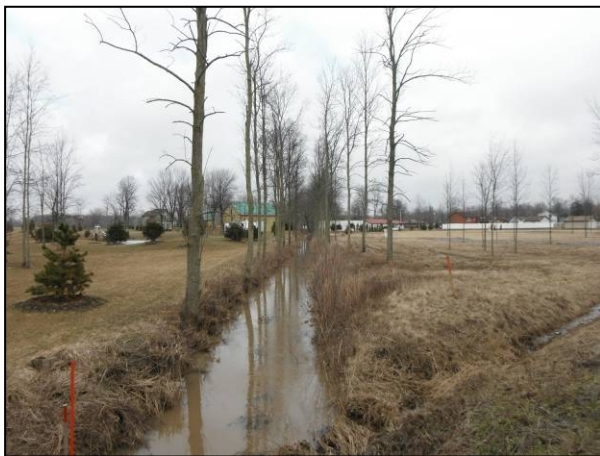
Reach 6a-B runs northeast from Killaly Street East, under Highway 3, to White Road. The adjacent land uses are anthropogenic and agricultural; the drain is mowed or cultivated to the top of bank on both sides throughout this reach. However, frequent 10-40cm DBH trees are present growing on the drain's banks.

Photo 47: Reach 6a-B, surrounding residential land

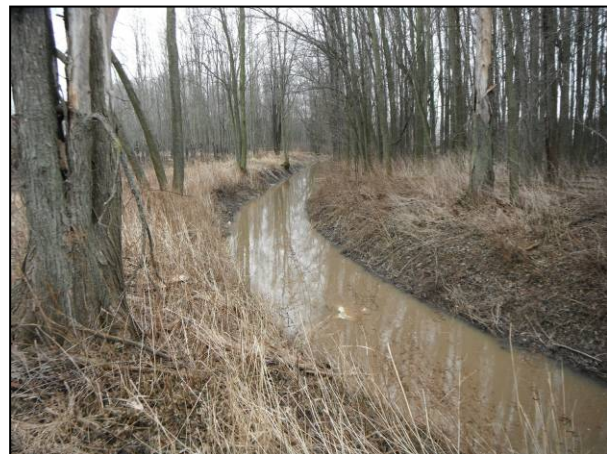
Photo 51: Reach 8-B, channel character and surrounding vegetation

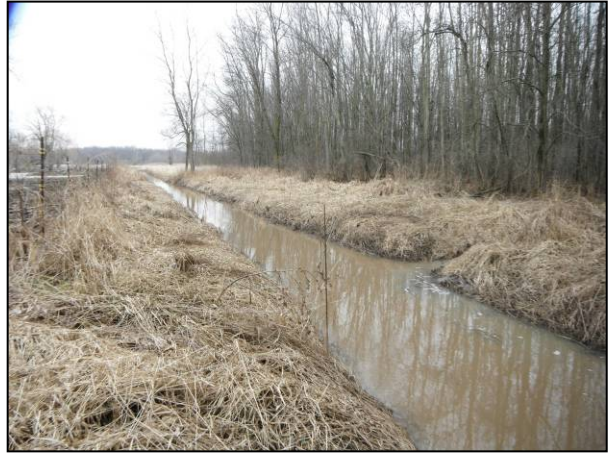
Photo 53: Reach 9-B, channel character and adjacent vegetation

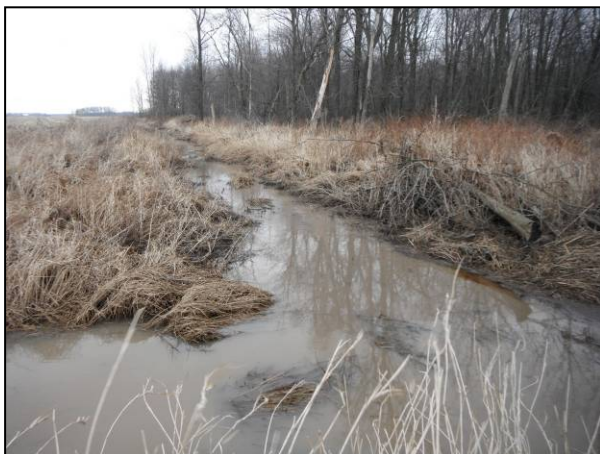
Reach 10-B runs generally north-south from Concession 2, splitting in two after approximately 300m; one branch continues north-south along the edge of a deciduous swamp and the other runs east-west to White Road. The north-south branch of this reach has a deciduous swamp on its east side and agriculture to the west while the West Branch of the Beaver Dam Drain has agriculture on both sides mowed to within 1m of the top of bank. The north-south branch has a 5-6m buffer zone between the drain and the cultivated area; this zone is mainly herbaceous with some shrubs and cut tree stumps.

Photo 54: Reach 10-B, channel character

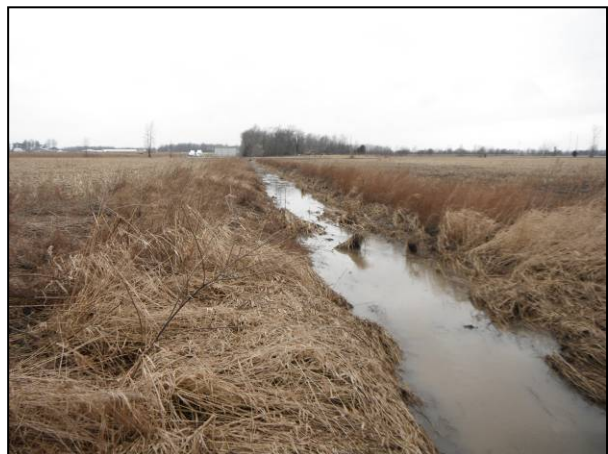
Photo 55: Reach 10-B, adjacent agricultural land

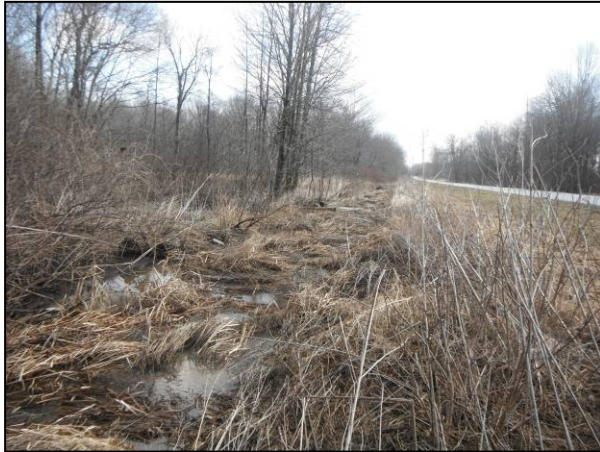
Reach 11-B, the East Branch of the Beaver Dam Drain, runs generally east-west along the southern edge of a deciduous swamp adjacent to Concession 2 and agricultural land. The drain runs alongside Concession 2 for approximately 0.5 km and then runs within deciduous swamp, cultural woodland, and cultural thicket for the remainder of this reach. In the time since D&A's field survey the portion of this reach east of the unopened portion of the Sherk Road allowance has been cleared on the south side of the drain for cultivation.

Photo 56: Reach 11-B, channel adjacent to Conc. 2

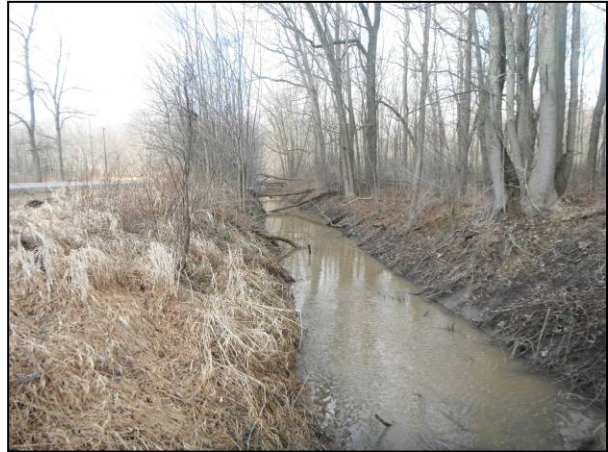
Photo 57: Reach 11-B, channel character

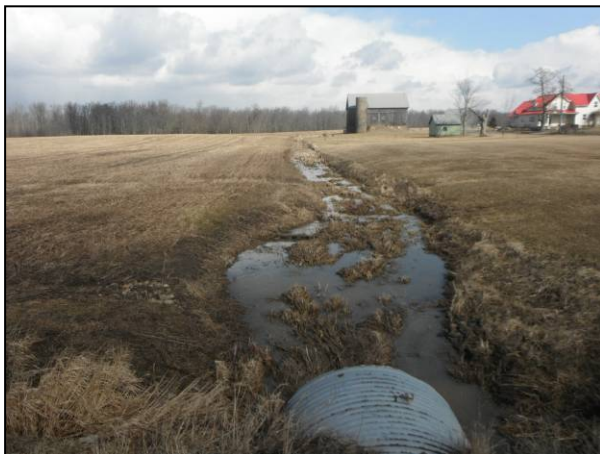
Reach 12-B runs generally north-south from the edge of a deciduous woodlot to the drain's upstream beginning at Concession 2. This reach is cultivated to the top of bank with scattered shrubs and cattails growing within the channel. The status of the drain under the Drainage Act currently ends here, however the watercourse continues in a north-easterly direction to Brookfield Road as a combination grassed waterway and tile sub-drainage system.

Photo 58: Reach 12-B, channel character

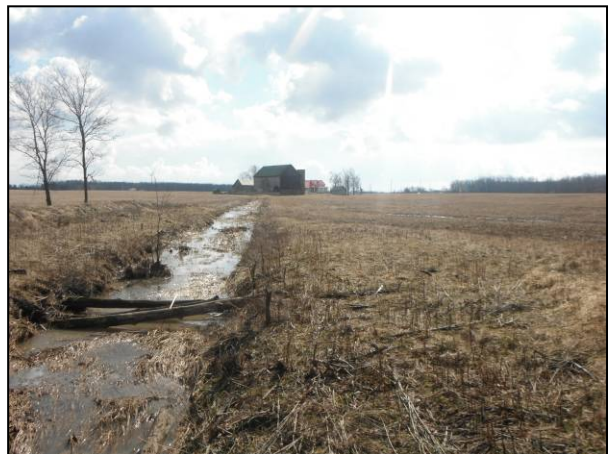
Photo 59: Reach 12-B, adjacent agricultural land

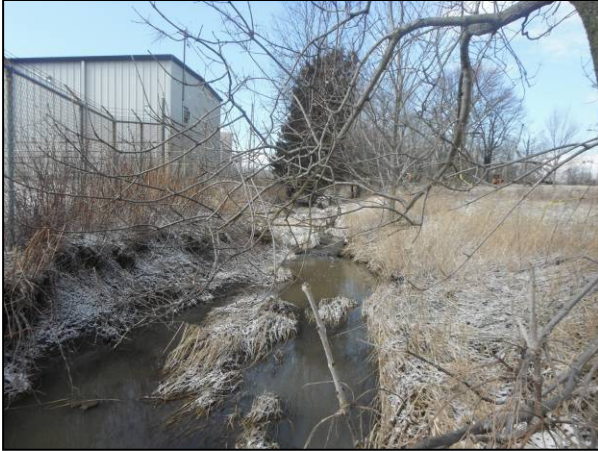
Reach 13-B, the West Branch of the Beaver Dam Drain, runs generally east-west between an industrial property, a former residential property, and agricultural land, ending at a deciduous forest that fronts onto Miller Road. The reach is generally treed to the top of bank except through parts of the agricultural area. Some concrete structures, pipes, and a bridge associated with the adjacent waste treatment facility have been installed in this reach of the drain.

Photo 60: Reach 13-B channel character and adjacent residential/commercial land

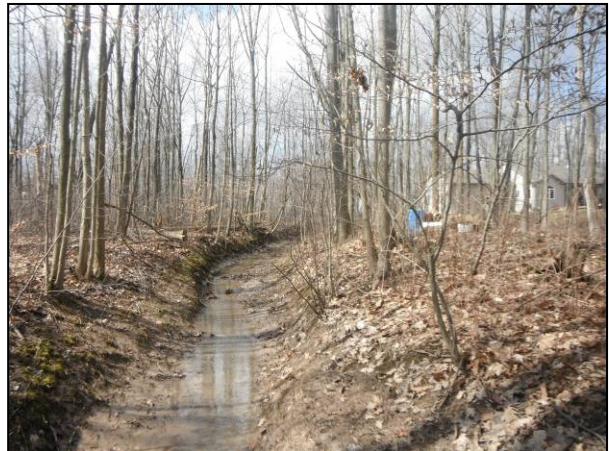
Photo 63: Reach 14-B, adjacent forest
